Innovative characterization and monitoring solutions for rockfall prone areas

Giordan Daniele

CNR IRPI - Geohazard Monitoring Group

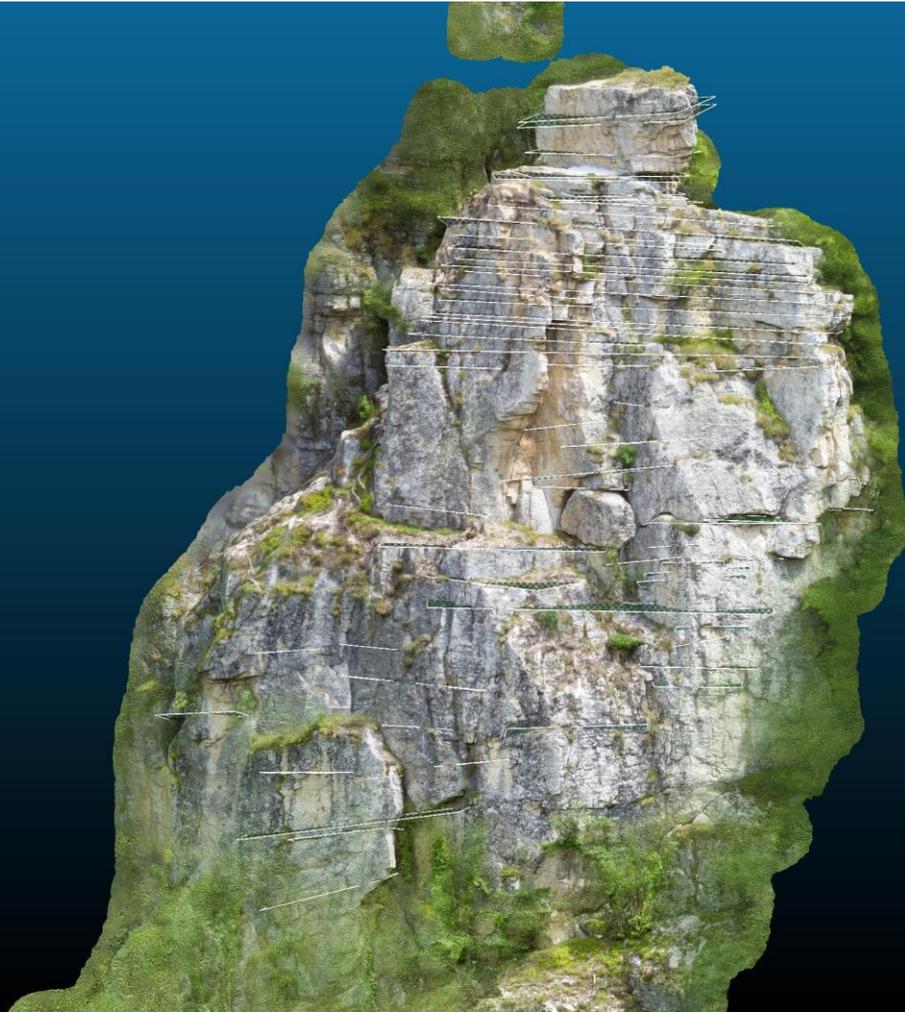
Ormea rock falls prone area

BEDDING

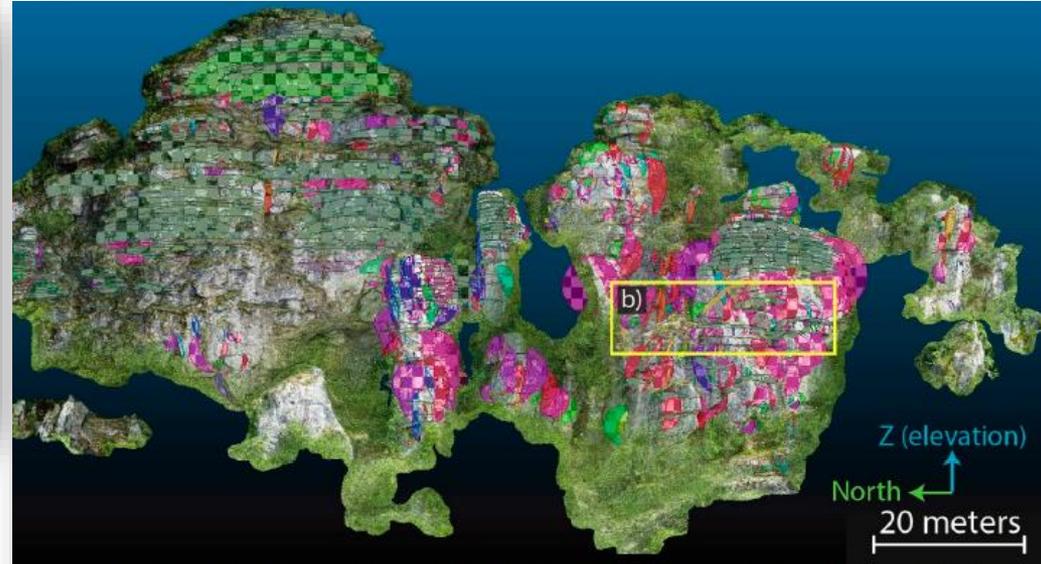
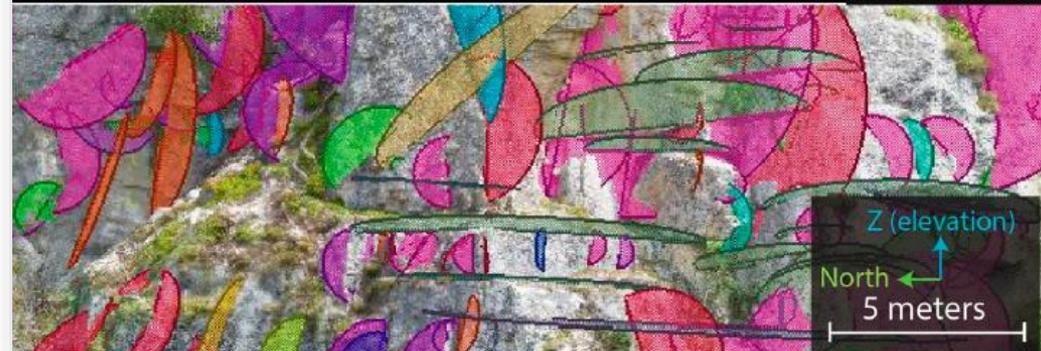
3D ROck Slope Kinematic Analysis (ROKA)

The open source ROKA code is able to detect critical joints combinations using a mobile window that checks all the possible discontinuity combinations according to Markland test

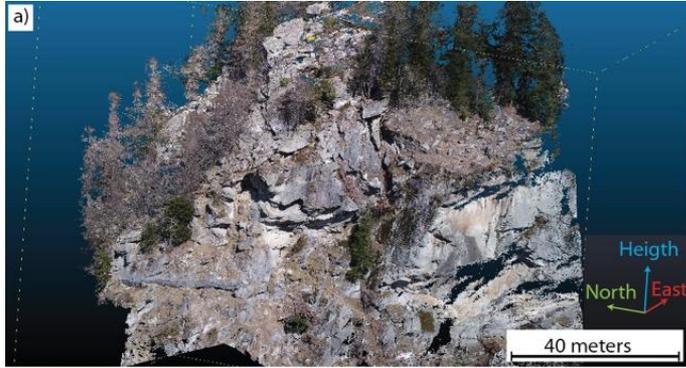
Gallivaggio rockfall

The estimated volume of the potentially unstable rock block was 8240 m^3

The volume of the fallen rock mass thus calculated was of ca 6730 m^3 .

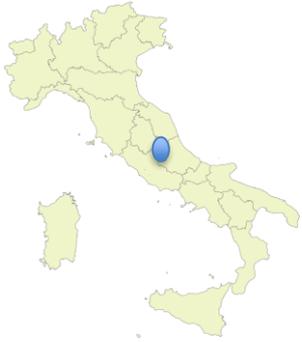
Villanova di Accumoli earthquake induced rockfall

Villanova di Accumoli is one of the most damaged town by the seismic sequence that hit the central part of Italy in the second half of 2016. The town was strongly damaged by the earthquake sequence and the area was also affected by the activation of several slope instabilities. Rock falls represented one of the most frequent instabilities that threatened in particular the viability and contributed to the loss of road connection in this mountainous area.

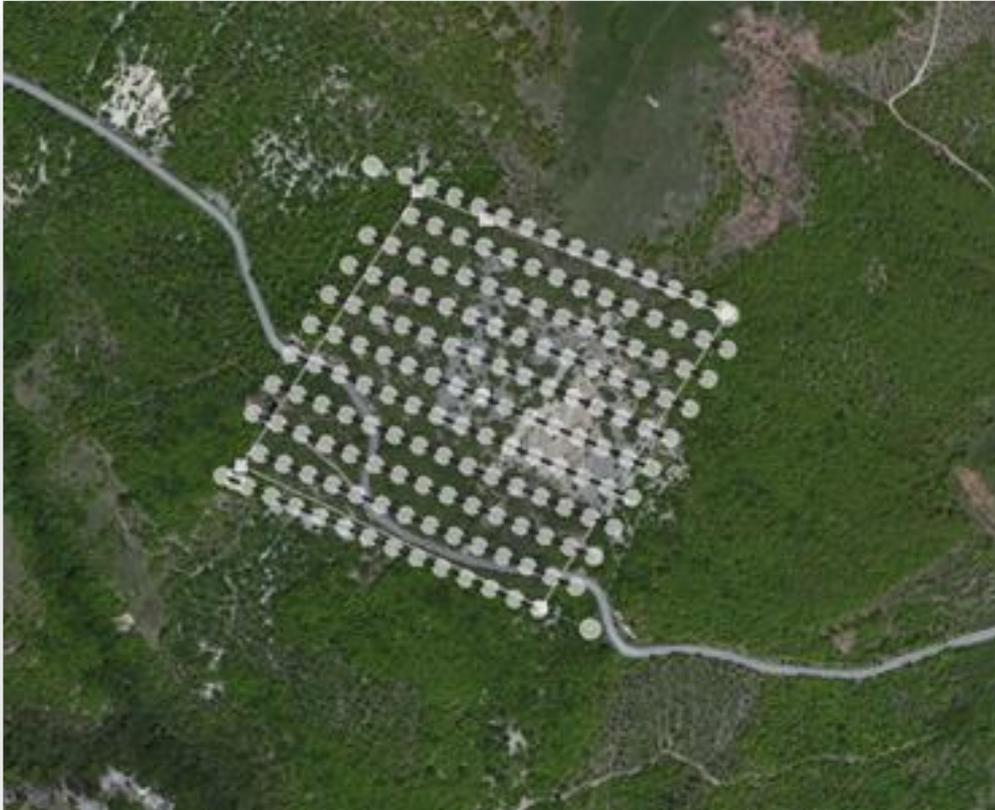
Villanova di Accumoli earthquake induced rockfall

STEP 1 OPTICAL RPAS ACQUISITION OF THE STUDIED AREA

The 6,500 m² area was covered by a total 161 photograms by a 34 Mpixel camera, obtaining a 1.5 cm/pixel Ground Sampling Distance (GSD).

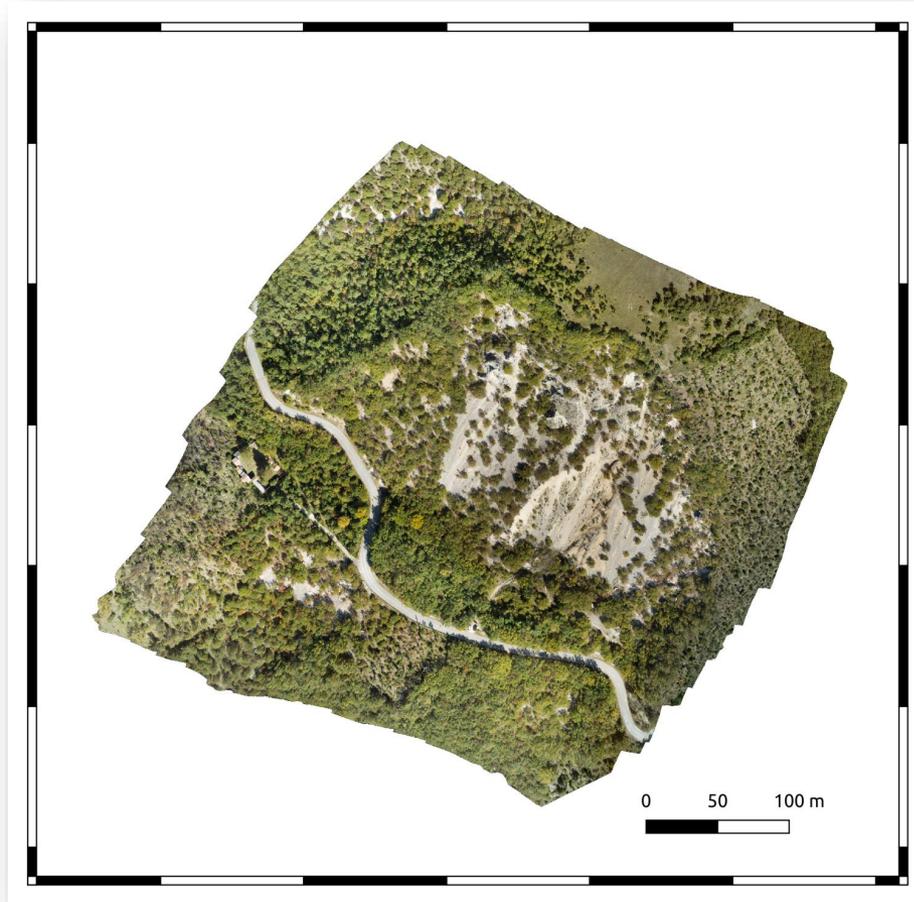
Villanova di Accumoli earthquake induced rockfall

STEP 2 STRUCTURE FROM MOTION RESULT: ORTOPHOTO

The final orthophoto has a resolution of 2.5 cm, whereas the DSM has a resolution of 20 cm.

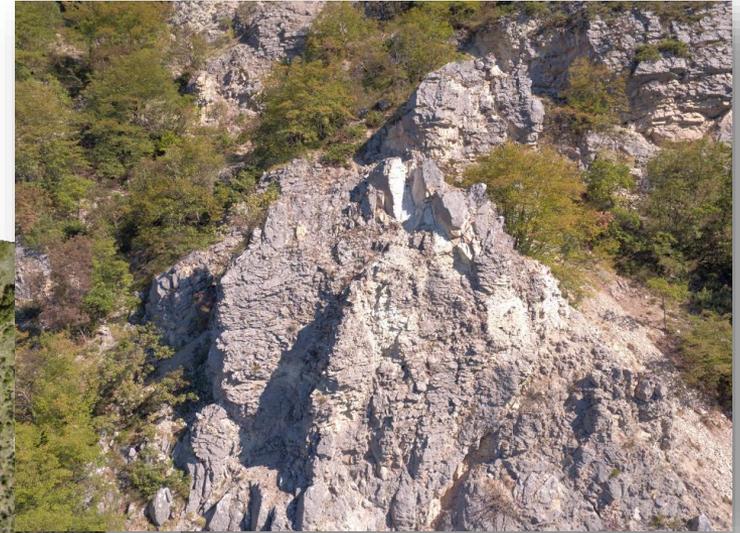
Rockfall vs monitoring approaches

The target of monitoring activity is the system composed by the rockfall prone area and the active and passive elements installed to reduce the rockfall risk

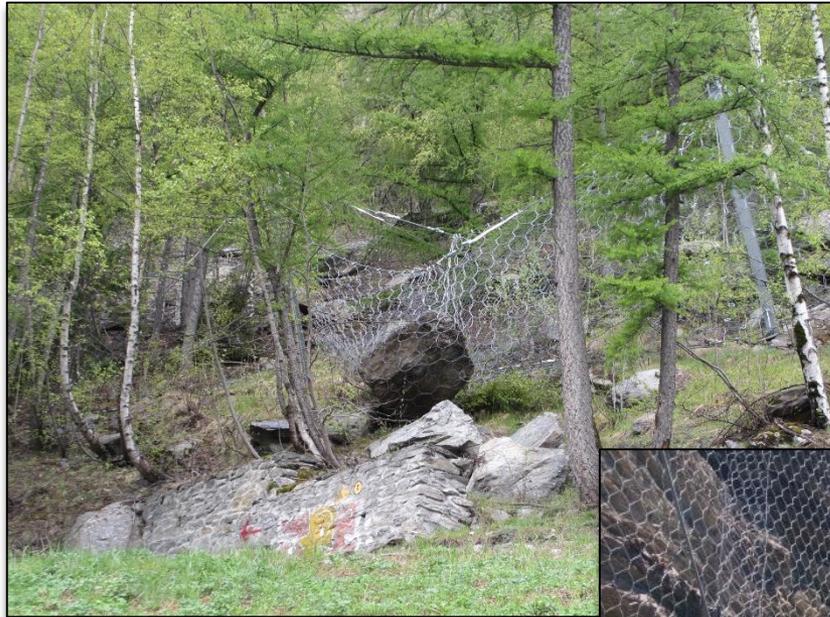
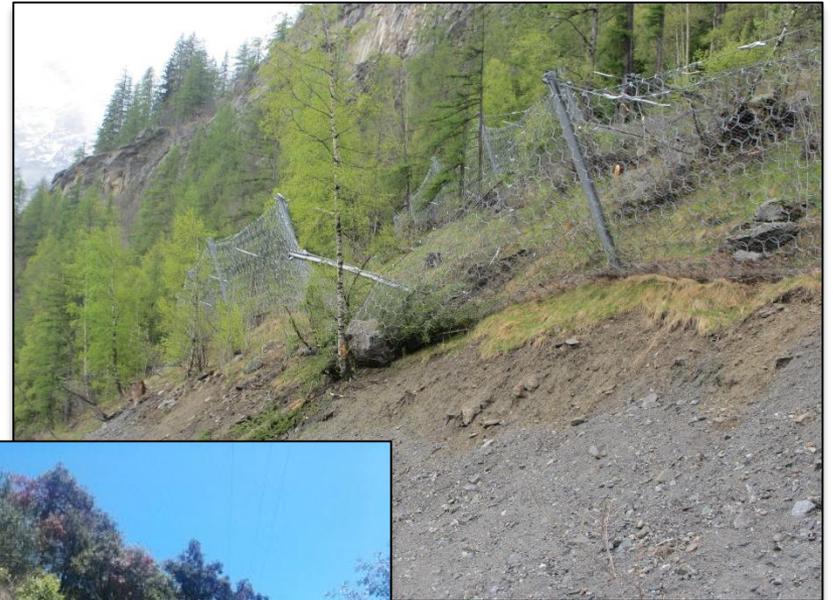
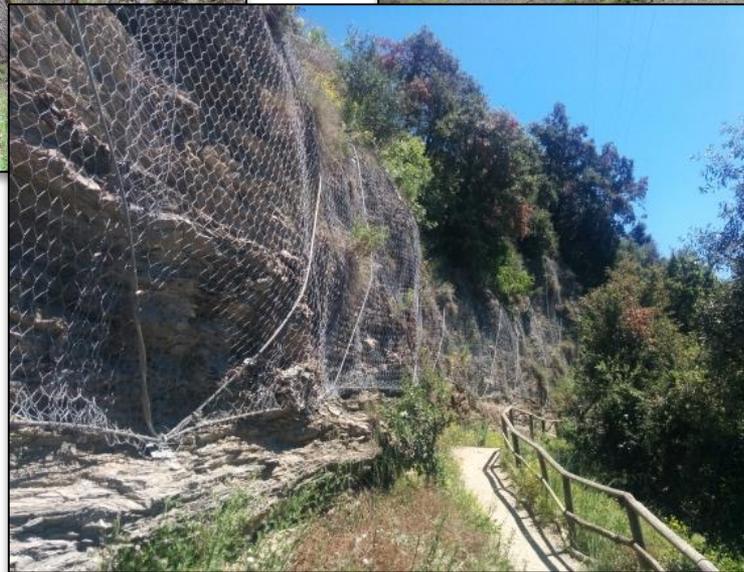
LASMON SMART NETWORK

Landslide Smart Monitoring Network
